November 11, 2019

Re: Response to USEPA Request for Information
Docket No. CWA-308-R01-FY-19-32
Discharge of Sulfuric Acid
Barnhardt Manufacturing Company
247 Main Road, Colrain, MA
MassDEP RTN 1-20919
OEG Project No. 3958

Barnhardt Manufacturing Company, 247 Main Road, Colrain, MA – Photo Log

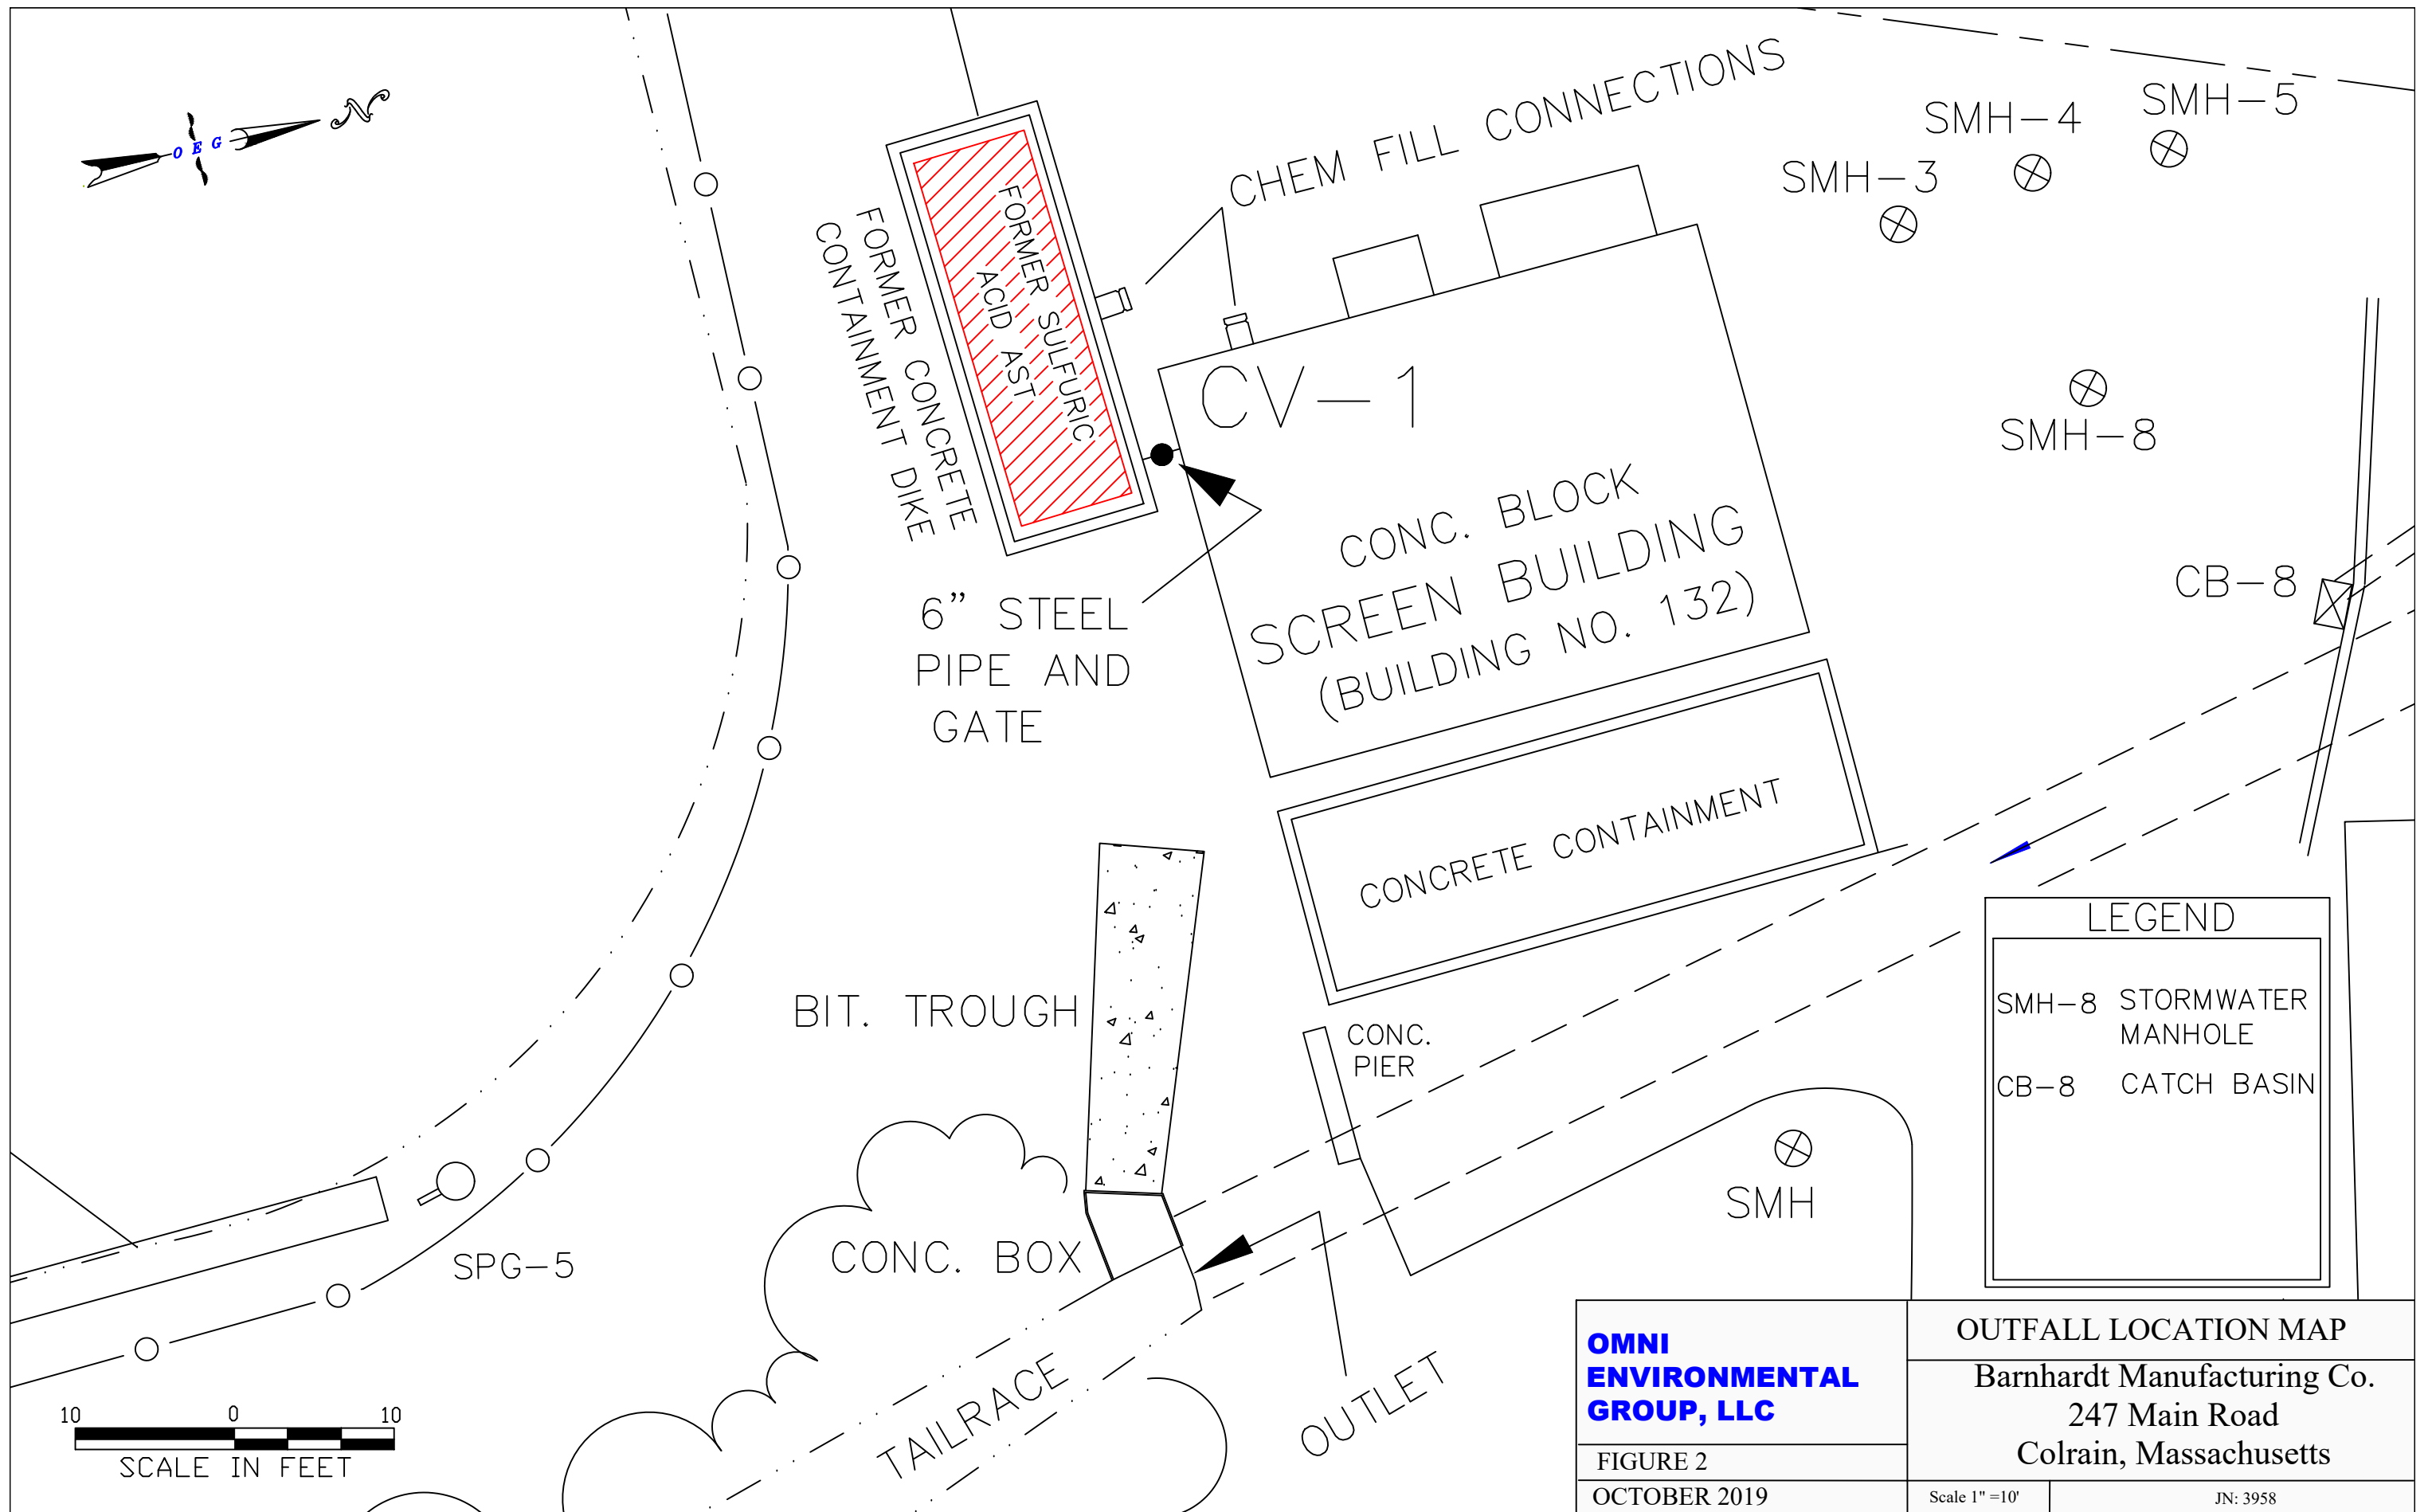
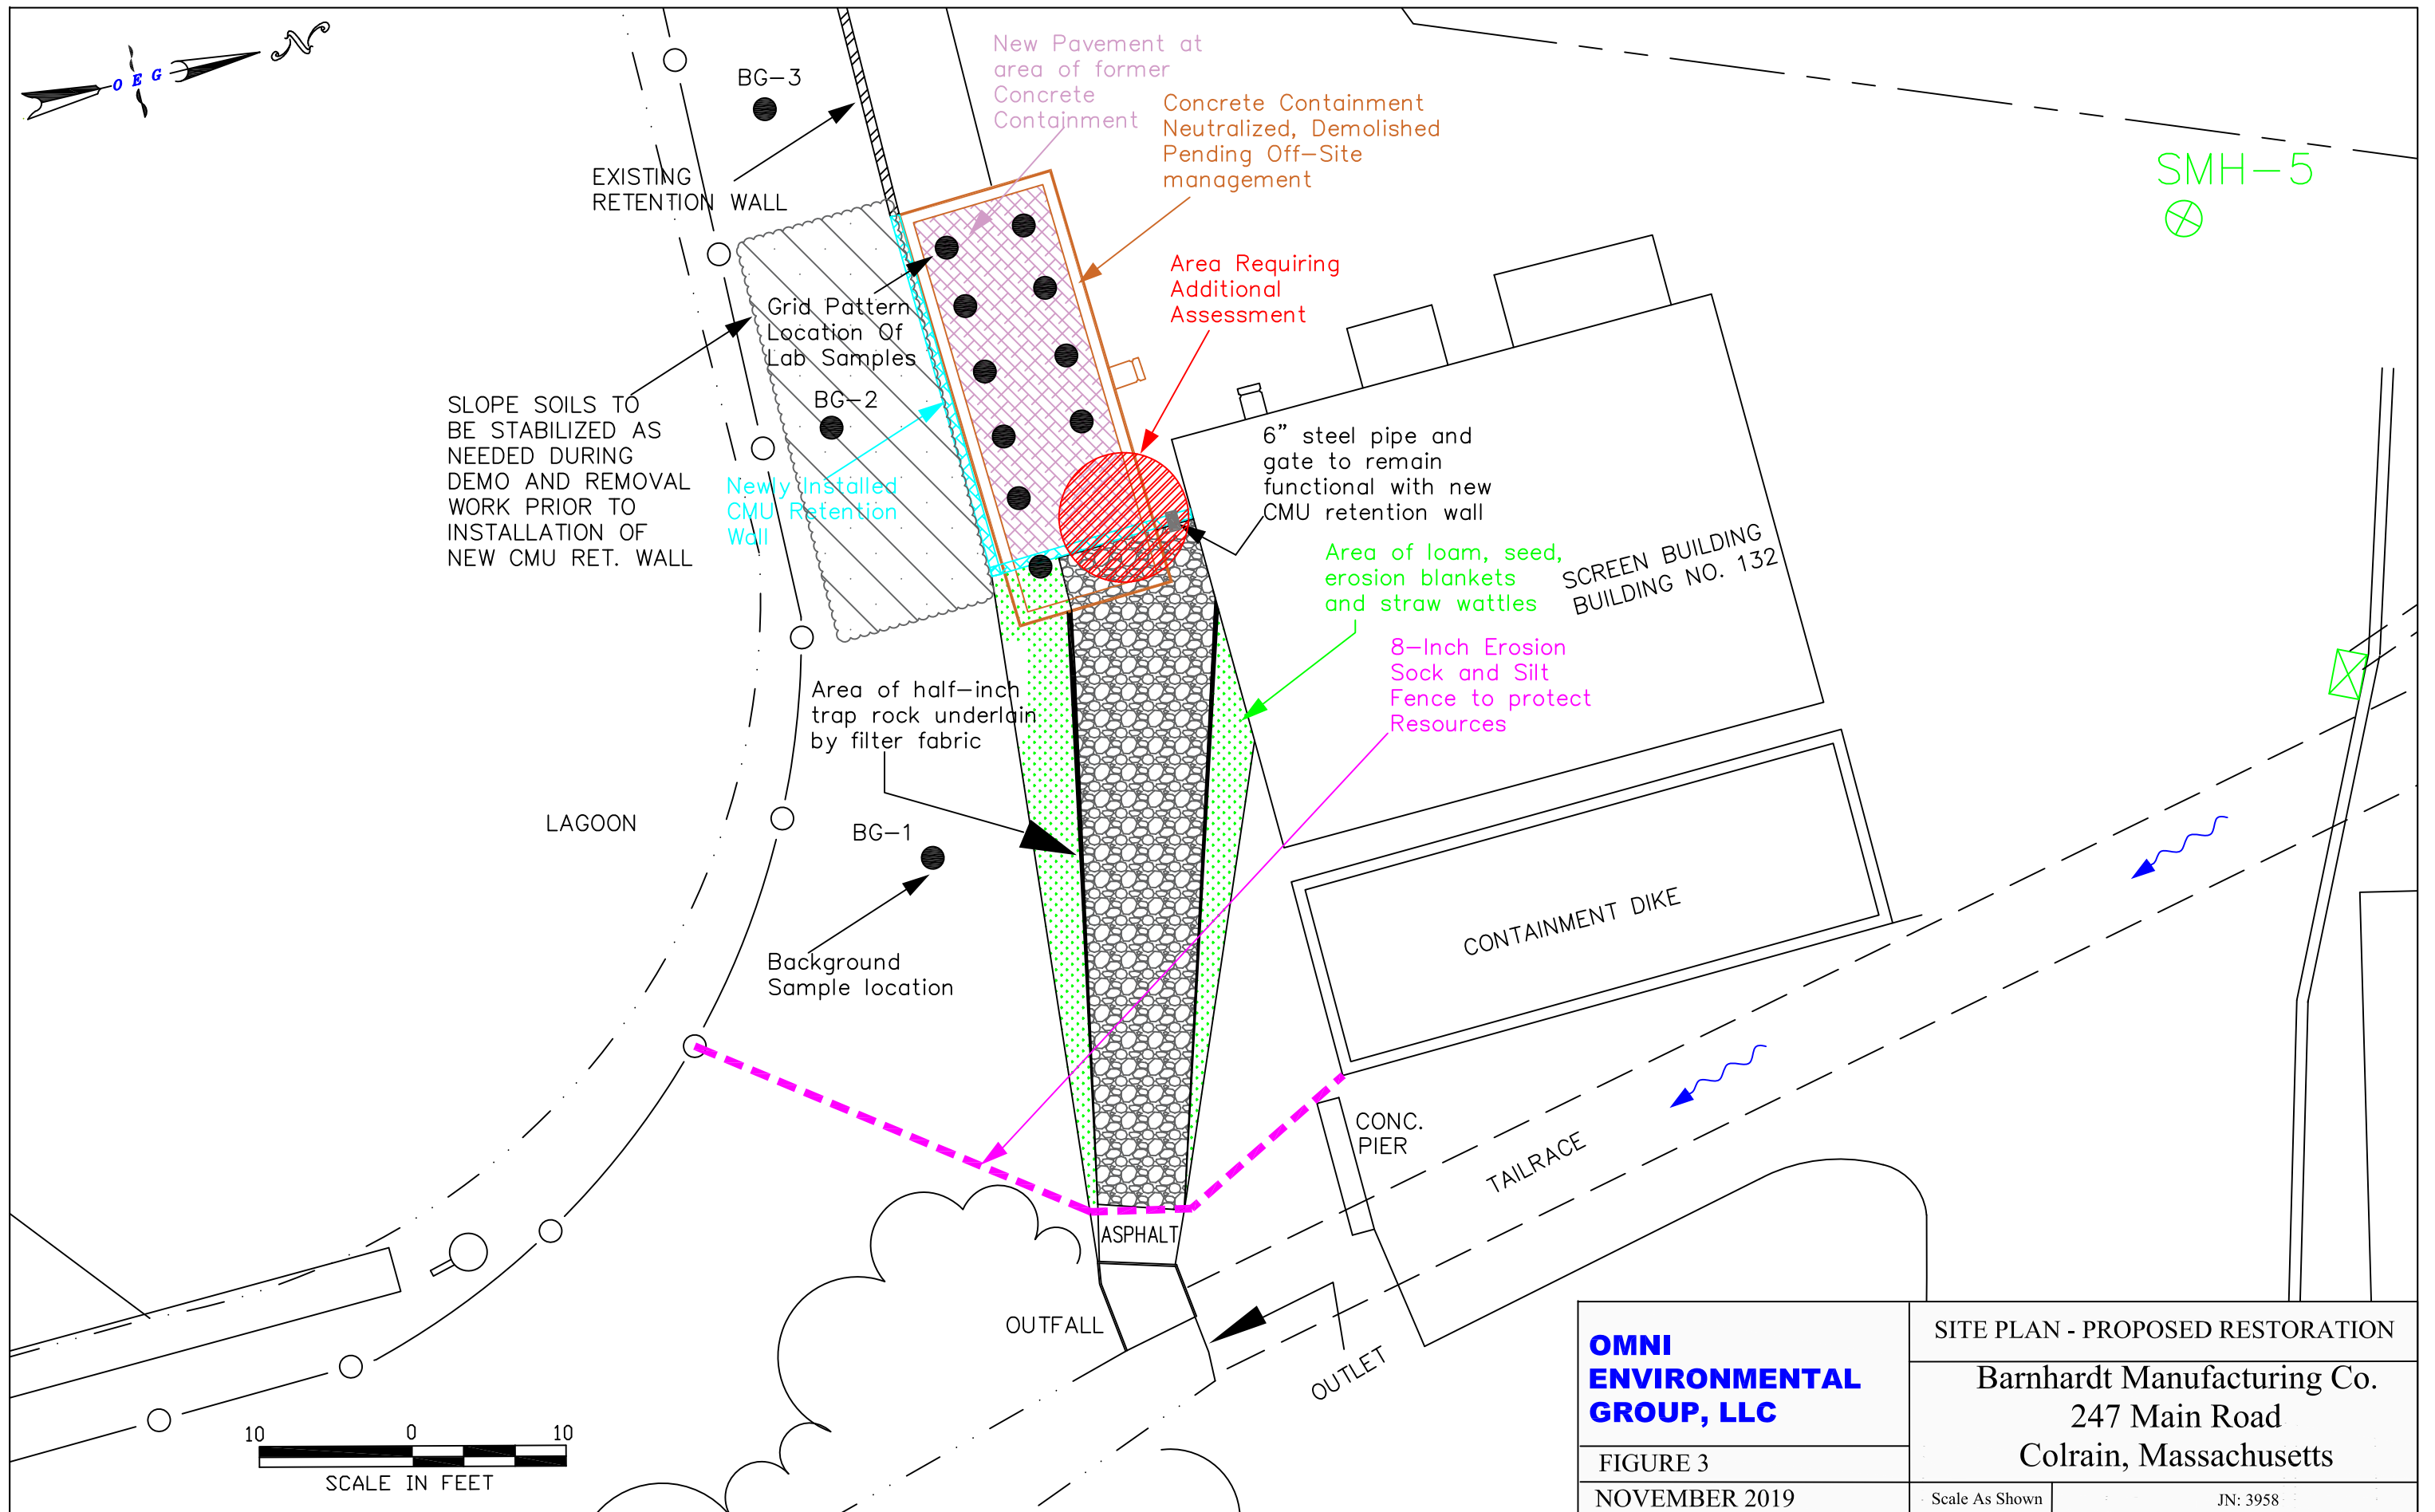
FIGURE 3
NOVEMBER 2019

- *Refer to [Table 1](#) and [Table 2](#) for analytical data generated to date and [Figure 3](#) for a depiction of completed excavation areas, confirmatory soil sample locations, restoration details and other pertinent Facility features in the vicinity of the release location. These tables and Site Plan are presented in [Attachment-7](#)*
